Dear Luhrs Owner:

Luhrs needs your assistance. We have recently started a preliminary review and metallurgical analysis of Marine Hardware supplied ball valves, which were installed by us as early as the year 2001 through the year 2007. If your hull number indicates that your boat was constructed in any of these years and if your hull is out of the water for the season or when it is removed from the water for periodic maintenance, we are asking for you to examine each of the several ball valves that were installed in your boat. We are asking for this examination to be conducted as soon as practicable, even if you have been following our recommendations described in the Spring Tuneup Newsletters, Chapman's Manual or other standard maintenance publications.

Model & hull numbers involved are as follows

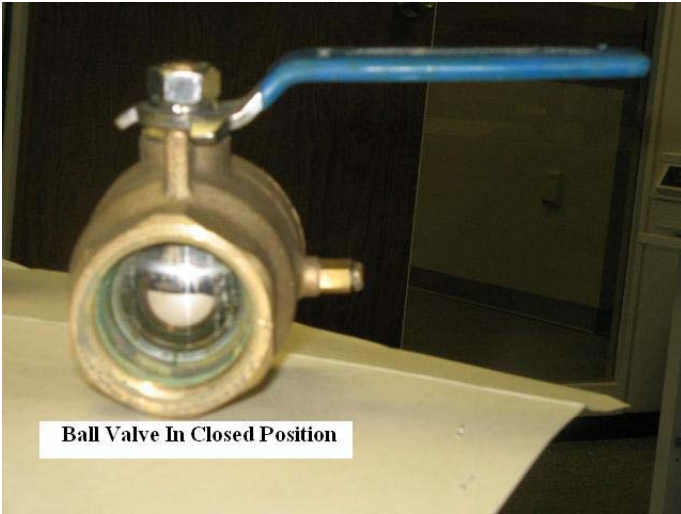
Ball Valve In Closed Position

To conduct this examination safely and appropriately, the boat must be out of the water for the examination, because the ball in the valve has to be seen opening and closing with the stem's and handles operation. Once out of the water the movement of the ball can be seen through the external thru hull(s) or (on some models) by removing the hose attached to the inlet side of the ball valve. According to your boat model this will allow the visual inspection mentioned above.

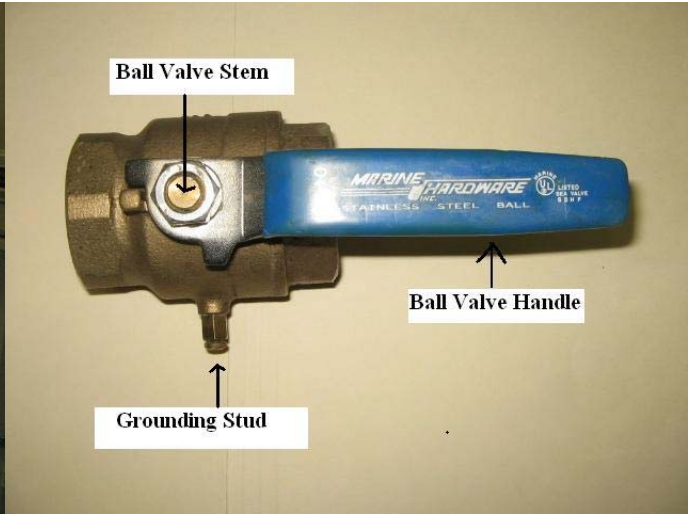
Our preliminary information is that corrosion may affect the stem or handle of the ball valve, which handle may turn without the handle actually opening and closing the ball valve as intended in the event of maintenance or an emergency.

Ball Valve Stem

Ball Valve Handle

Grounding Stud

As of this date, we understand from the ball valve supplier that it is its opinion that corrosion may not be occurring to the ball valve's assembly because it is cathodically protected, as it should be in your boat. Nonetheless, we are not sure that cathodic protection will provide an adequate defense, which could leave the handle or stem unable to close the internal ball of the valve. Because cathodic protection or the bonding system may indeed be a factor, please also check to verify that your bonding system or cathodic protection system is working, clean and connected to all the ball valves examined. In the event you choose to replace the ball valves, please assure that the internal bonding (cathodic protection) system remains effective for any parts replaced.

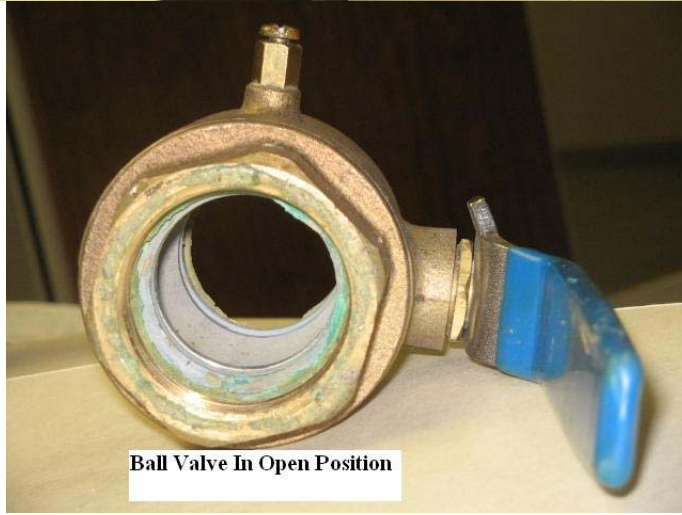
Ball Valve In Open Position
